**DOE CHALLENGE HOME  
CASE STUDY****BPC Green  
Builders**

New Fairfield, CT

**FEATURED HOME/DEVELOPMENT:****Project Data:**

- Name: Candlewood Hills Rebuild
- Location: New Fairfield, CT
- Layout: 3 bedrooms, 3 baths, 2 floors
- Conditioned Space: 3,052 ft<sup>2</sup>
- Completion: Dec. 2012
- Climate Zone: 5A
- Category: Custom

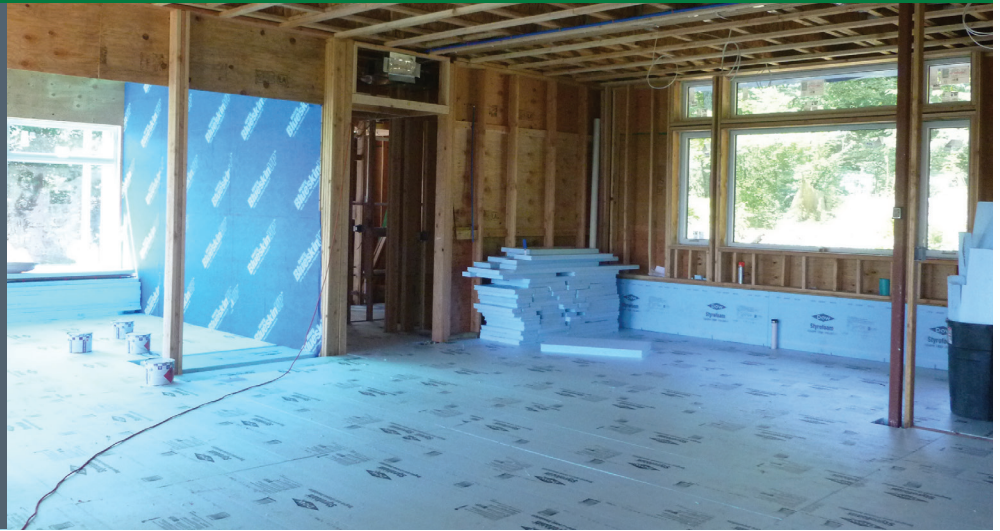
Rigid foam insulation covered the slab foundation, which included some old existing slab plus a new poured slab. The rigid foam also lined the interior and exterior of the foundation walls, providing a snug thermal break and moisture protection for first-floor radiant heating loops, which were set in 2 inches of gypcrete.

Some portions of the old slab were removed and replaced with new concrete slab. Then a liquid gypsum material was poured over both the new and old slab to level the surface. This was covered with R-20 (4 inches) of extruded polystyrene (XPS) rigid foam insulation. The radiant floor tubing was installed on the XPS and 2 inches of gypcrete was poured over this as a base for the tile floors. Rigid XPS (R-15) was installed along the foundation walls, 3 inches thick on the exterior and 1.5 inches thick on the interior, before the slab was poured.

- **Foundation:** R-20 (4 inches) XPS rigid foam insulation over existing slab and under new slab. 3 inches (R-15) XPS exterior, plus 1.5 inch (R-7.5) XPS on interior of foundation walls

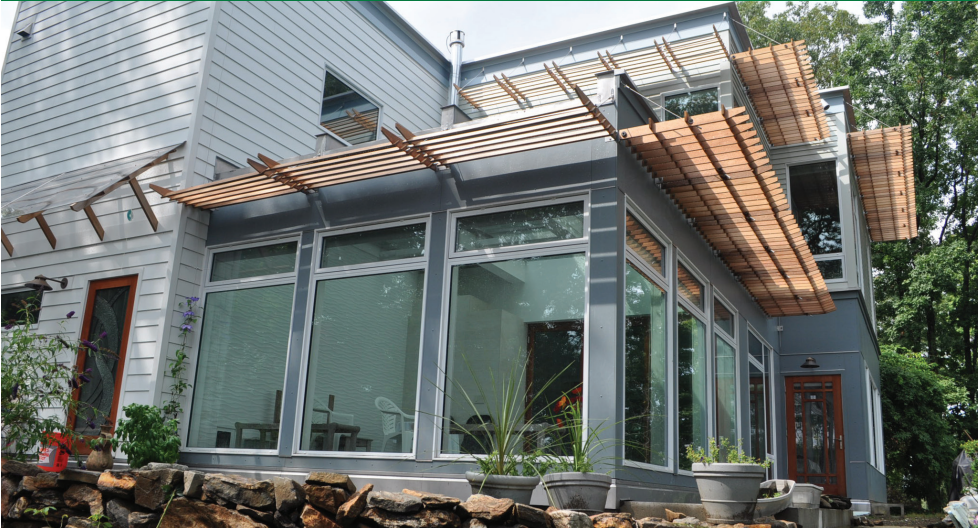
Nearly every room and closet in the home receives natural light through triple-pane low-emissivity windows or insulated solar tubes. Extra attention to air sealing helped the home achieve a very low air leakage rate of 0.45 ACH 50.

The highly insulating envelope was also heavily air sealed with all holes, joints, and cracks caulked or filled with spray foam. The Challenge Home requires that every home be tested for air leakage with a blower-door test. BPC Green Builders achieved a very low score of 0.45 air changes per hour at 50 Pascals pressure.

Every room in the home has natural daylighting via windows or solar tubes, including every closet but one—the closet under the stairs. All but one fixture in the home use LED or CFL bulbs; most are screw-based fixtures to accommodate future improvements in light sources. McKay designed the home's lighting plan, which includes 35 different lighting zones. Indirect lighting above built-in shelves is set by timers to consist of brighter lighting in the morning and warmer tones in the evening to encourage the occupants to wake up and feel sleepy at appropriate times. All of the actual dimmers and switches are high up in the closet, but 7-button, 1-gang controllers were installed on the walls to lump controls into fewer switch plates.

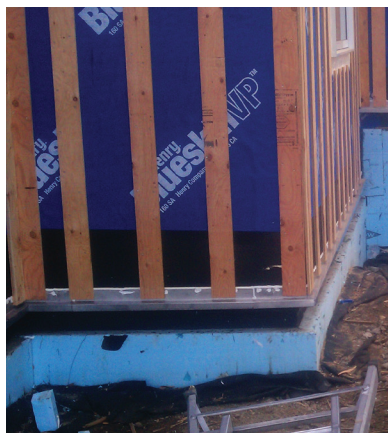
The exterior sheathing of the home was wrapped with a self-adhering vapor-permeable house wrap that serves as a weather-resistant air and water barrier. Furring strips were installed over this barrier allowing it to serve as a drainage plane for any bulk water that manages to get past the fiber cement siding.

The double-wall construction consists of a 2x6 24-inch on-center outer wall and a 2x4 24-inch on-center inner wall spaced 0.5 inches apart with staggered studs to provide a 9.5-inch cavity that was filled with R-33 of blown cellulose. The outer wall was sheathed with CDX plywood, covered with a layer of vapor-permeable, self-adhered, air- and water-barrier house wrap over which were installed 1x3 furring strips and fiber cement siding.
