**DOE CHALLENGE HOME
CASE STUDY****BPC Green
Builders**

New Fairfield, CT

- Name: Candlewood Hills Rebuild
- Location: New Fairfield, CT
- Layout: 3 bedrooms, 3 baths, 2 floors
- Conditioned Space: 3,052 ft²
- Completion: Dec. 2012
- Climate Zone: 5A
- Category: Custom

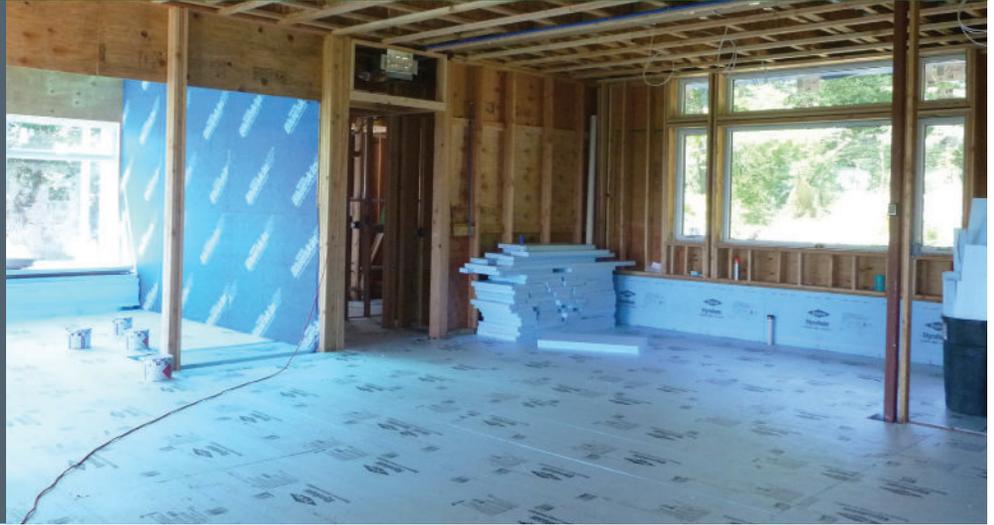
Rigid foam insulation covered the slab foundation, which included some old existing slab plus a new poured slab. The rigid foam also lined the interior and exterior of the foundation walls, providing a snug thermal break and moisture protection for first-floor radiant heating loops, which were set in 2 inches of gypcrete.

Some portions of the old slab were removed and replaced with new concrete slab. Then a liquid gypsum material was poured over both the new and old slab to level the surface. This was covered with R-20 (4 inches) of extruded polystyrene (XPS) rigid foam insulation. The radiant floor tubing was installed on the XPS and 2 inches of gypcrete was poured over this as a base for the tile floors. Rigid XPS (R-15) was installed along the foundation walls, 3 inches thick on the exterior and 1.5 inches thick on the interior, before the slab was poured.

- **Foundation:** R-20 (4 inches) XPS rigid foam insulation over existing slab and under new slab. 3 inches (R-15) XPS exterior, plus 1.5 inch (R-7.5) XPS on interior of foundation walls

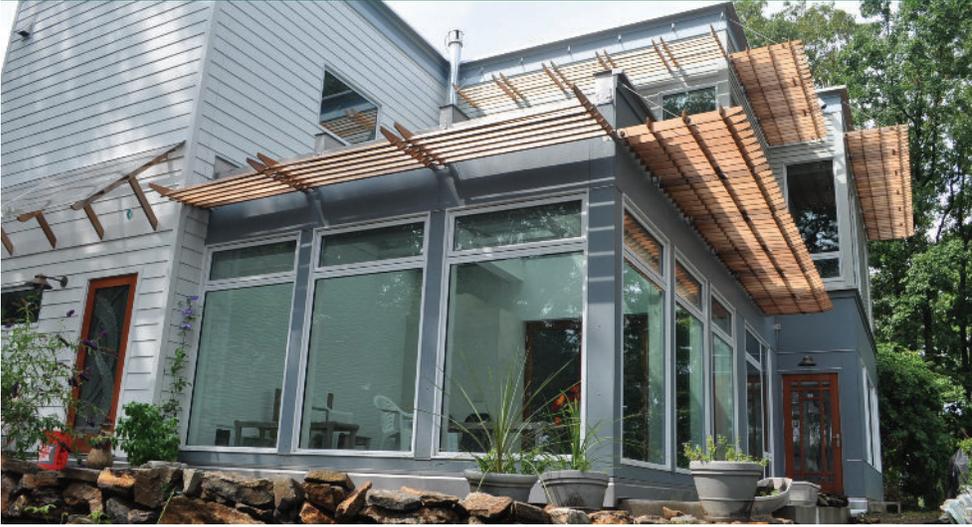
Nearly every room and closet in the home receives natural light through triple-pane low-emissivity windows or insulated solar tubes. Extra attention to air sealing helped the home achieve a very low air leakage rate of 0.45 ACH 50.

The highly insulating envelope was also heavily air sealed with all holes, joints, and cracks caulked or filled with spray foam. The Challenge Home requires that every home be tested for air leakage with a blower-door test. BPC Green Builders achieved a very low score of 0.45 air changes per hour at 50 Pascals pressure.

Every room in the home has natural daylighting via windows or solar tubes, including every closet but one—the closet under the stairs. All but one fixture in the home use LED or CFL bulbs; most are screw-based fixtures to accommodate future improvements in light sources. McKay designed the home's lighting plan, which includes 35 different lighting zones. Indirect lighting above built-in shelves is set by timers to consist of brighter lighting in the morning and warmer tones in the evening to encourage the occupants to wake up and feel sleepy at appropriate times. All of the actual dimmers and switches are high up in the closet, but 7-button, 1-gang controllers were installed on the walls to lump controls into fewer switch plates.

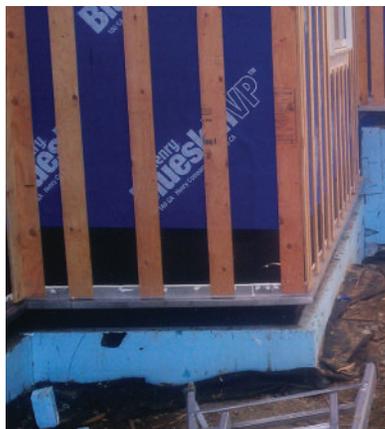
The exterior sheathing of the home was wrapped with a self-adhering vapor-permeable house wrap that serves as a weather-resistant air and water barrier. Furring strips were installed over this barrier allowing it to serve as a drainage plane for any bulk water that manages to get past the fiber cement siding.

The double-wall construction consists of a 2x6 24-inch on-center outer wall and a 2x4 24-inch on-center inner wall spaced 0.5 inches apart with staggered studs to provide a 9.5-inch cavity that was filled with R-33 of blown cellulose. The outer wall was sheathed with CDX plywood, covered with a layer of vapor-permeable, self-adhered, air- and water-barrier house wrap over which were installed 1x3 furring strips and fiber cement siding.
